CABIN HEAVY CONDENSATION

Reference: 21.00.00.068

A/C type/serie: A321

ATA: 21-00, 25-80, 53-20, ...

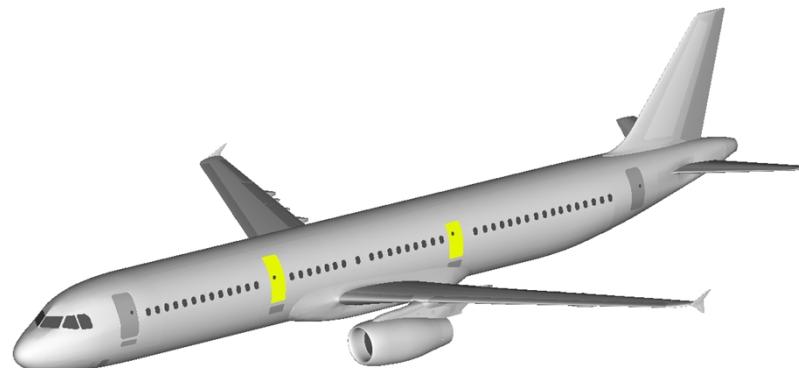
Recently, heavy condensation [and "rain in the plane"](#) have been observed in the cabin of recent A321.

Main cabin and structure impacted areas are located in the centre fuselage, close to the PAX doors 2 and 3.

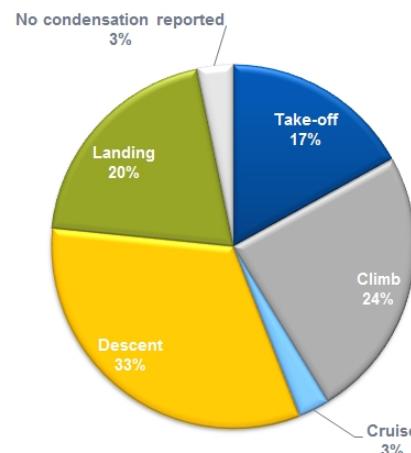
Water condensation leaks in the cabin (["rain in the plane"](#)) are mainly observed during climbing and descent phases.

Flight phases where condensation is mainly experienced

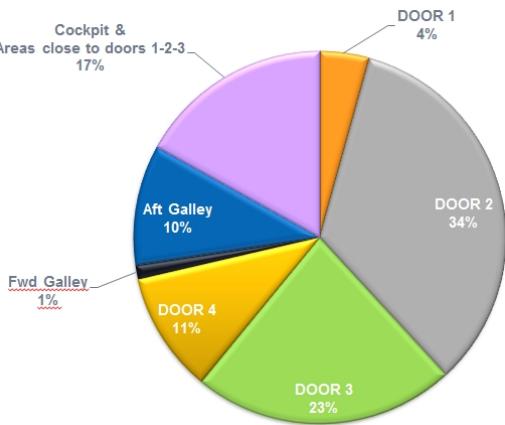
Main location where condensation is mainly experienced

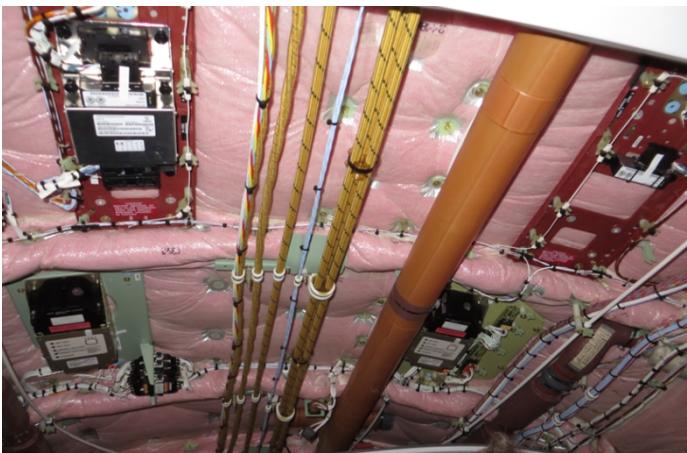
Water drops are observed coming from the cabin ceiling panels which may generate passenger discomfort. At the upper side of the fuselage, after removal of the ceiling panels, insulation blankets were found wet.

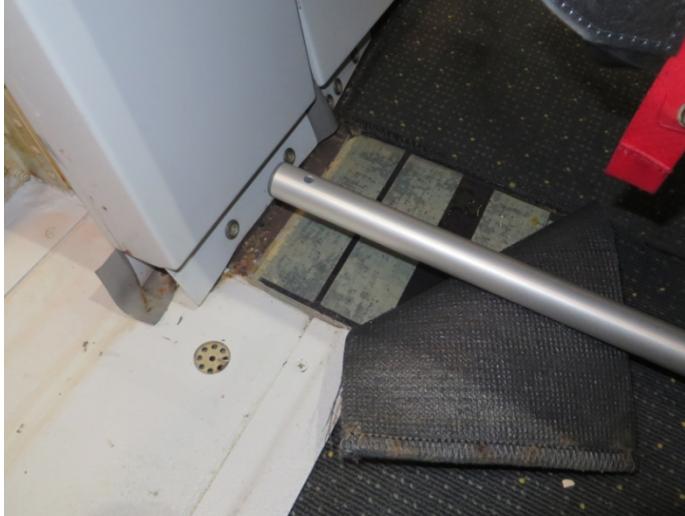
Carpets close to PAX doors 2 and 3 were also found wet.

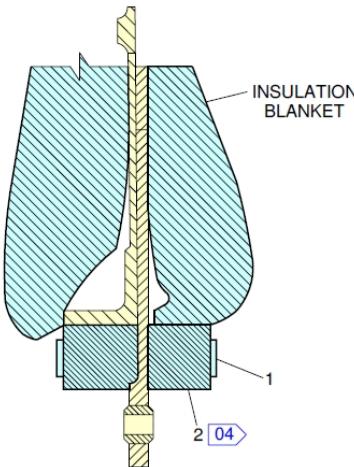
Recent investigations have been performed to identify contributors to the abnormal water penetration in the cabin. Regarding insulation blankets, some overlapping installations and cut-outs have been found perfectible.

Improvement of the installation of the insulation blankets,
