CABIN HEAVY CONDENSATION

Reference: 21.00.00.068

A/C type/serie: A321

ATA: 21-00, 25-80, 53-20, ...

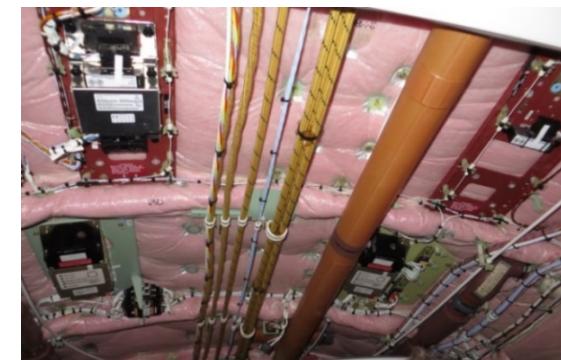
- Heavy condensation has been observed in the cabin of recent A321 aircraft.
- Main cabin and structure impacted areas are located close to the PAX door 2 and 3.
- Water condensation leaks are mainly found during climbing and descent phases.
- Consequence: Cabin elements and passenger comfort can be impacted in case of heavy condensation.
